Manhole Inspection Summary

Manhole # S11QQ1022MH

Insp Date: **11/2/06 9:46 AM**

Location Address: **2814 OAKLEY AVE**

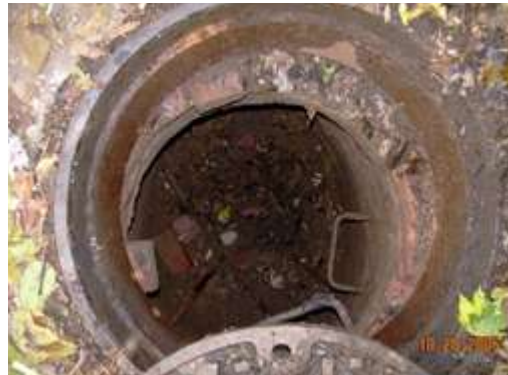
Top View

Channel debris.

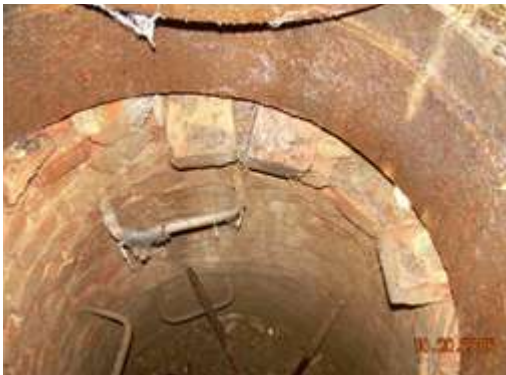
Defect

Frame leaks. Frame offset. Adjustment loose brick, deterioration, and infiltration. Corbel and Barrel infiltration.

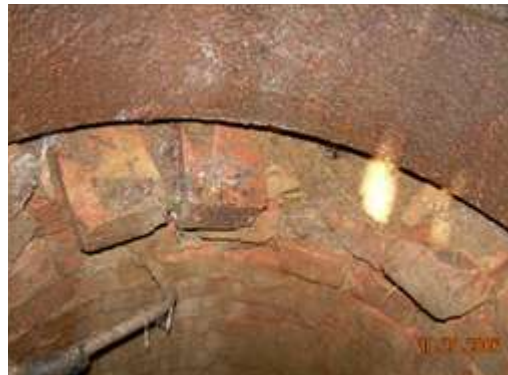
Defect

Frame leaks. Frame offset. Adjustment loose brick, deterioration, and infiltration. Corbel infiltration.

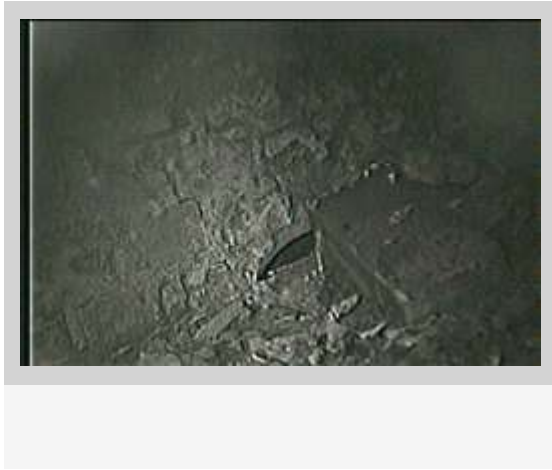
8 in. Circular Gravity Sewer
Pipe Out @ 12 O'Clock

Deposits: ☐ None ☒ **Mud** ☐ Sludge ☒ **Debris** ☐ Grease

Silt Depth: **6** (in.) Deposits Extent: **Heavy**
